# **INDOOR AIR QUALITY ASSESSMENT**

**Brimfield Elementary School  
22 Wales Road  
Brimfield, Massachusetts**

Prepared by:  
Massachusetts Department of Public Health  
Center for Environmental Health  
Bureau of Environmental Health Assessment  
Emergency Response/Indoor Air Quality Program  
May 2004

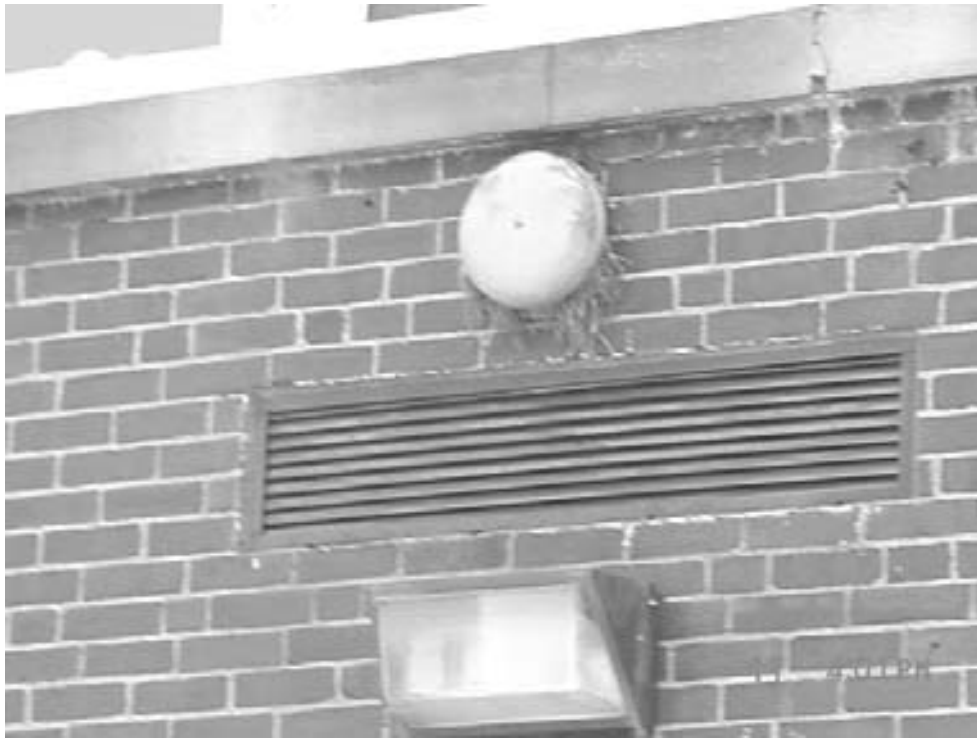
**Picture 1**

Signs of bird roosting and nesting materials were observed in a school bell directly above an air intake for a second floor univent (Picture 1). BEHA staff recommended that the nest be removed to prevent entrainment of bird wastes. Birds can be a source of disease, and bird wastes and feathers can contain mold and mildew, which can be irritating to the respiratory system. No obvious signs of bird roosting inside the building were noted by BEHA staff nor were such signs reported by occupants.

**Univent Fresh Air Intake, Note Bird's Nest Over Vent**

7. Remove bird's nests from vicinity of univent air intake (Picture 1). Inspect to ensure surfaces are free of nesting materials and bird wastes. Clean and disinfect intake vents with an appropriate antimicrobial where necessary.

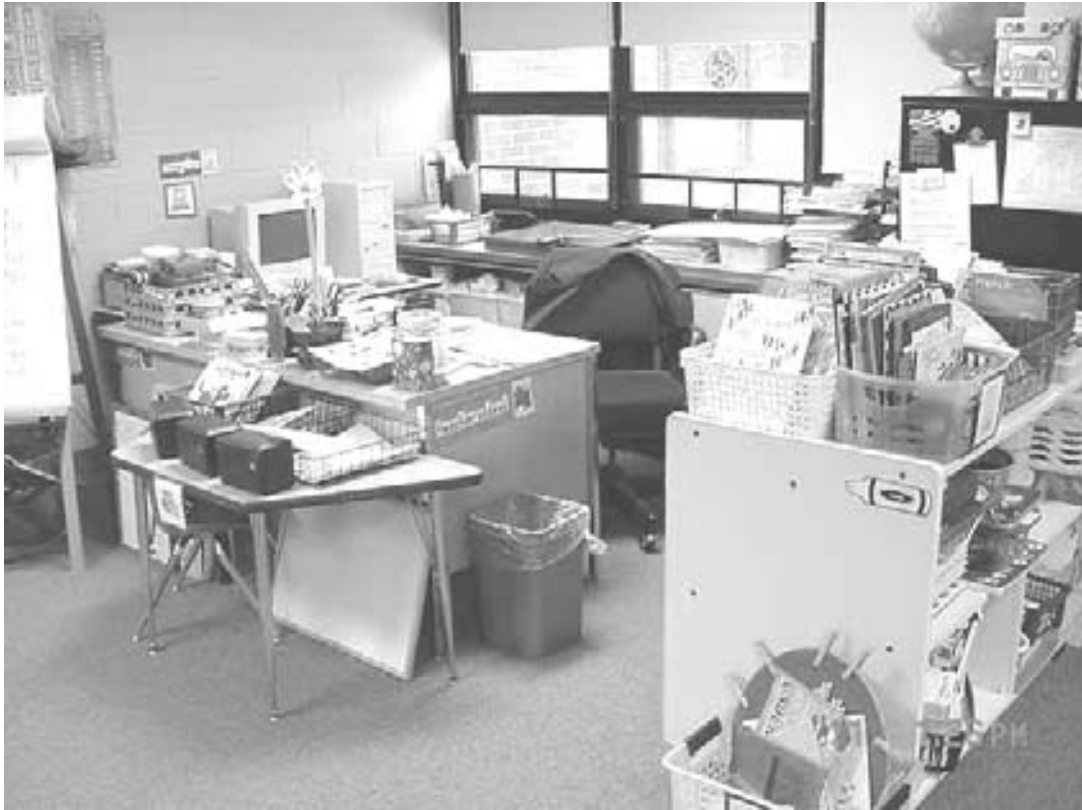
**Picture 2**

**Univent Obstructed by Furniture and Other Items**

3. Inspect rooftop exhaust motors and belts for proper function, repair and replace as necessary.
4. Remove all blockages from univents and exhaust vents.

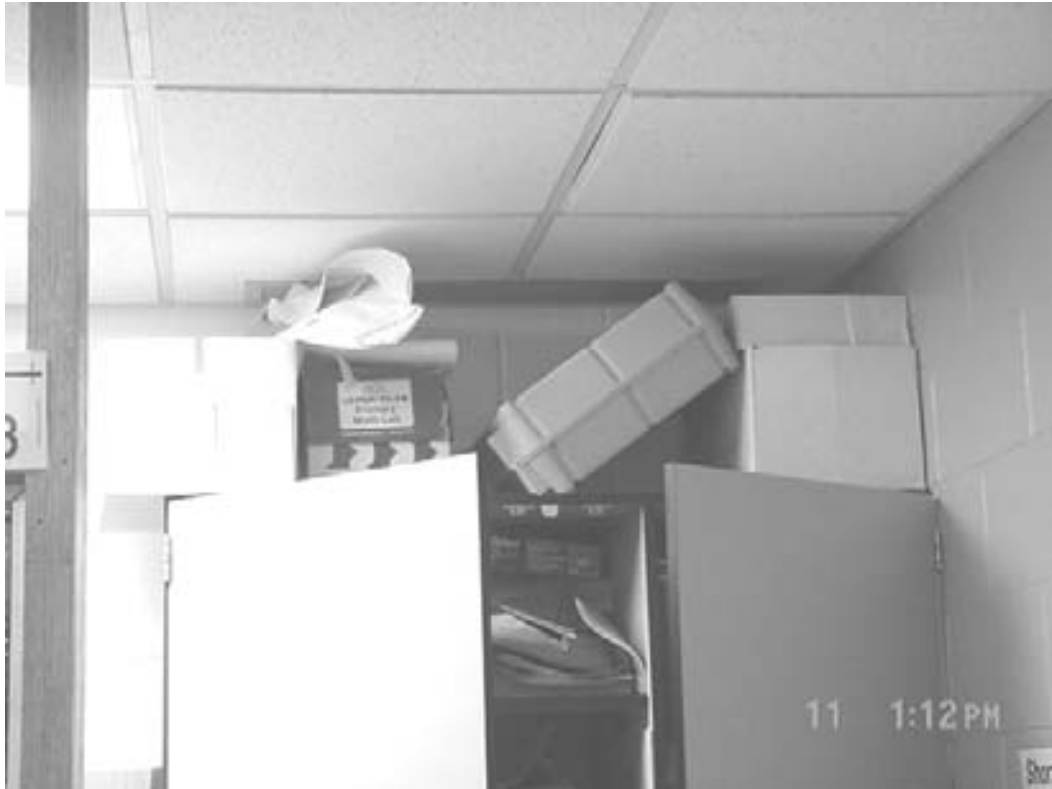
**Picture 3**

**Items Stored on top of Storage Cabinet Obstructing Ceiling Exhaust Vent**

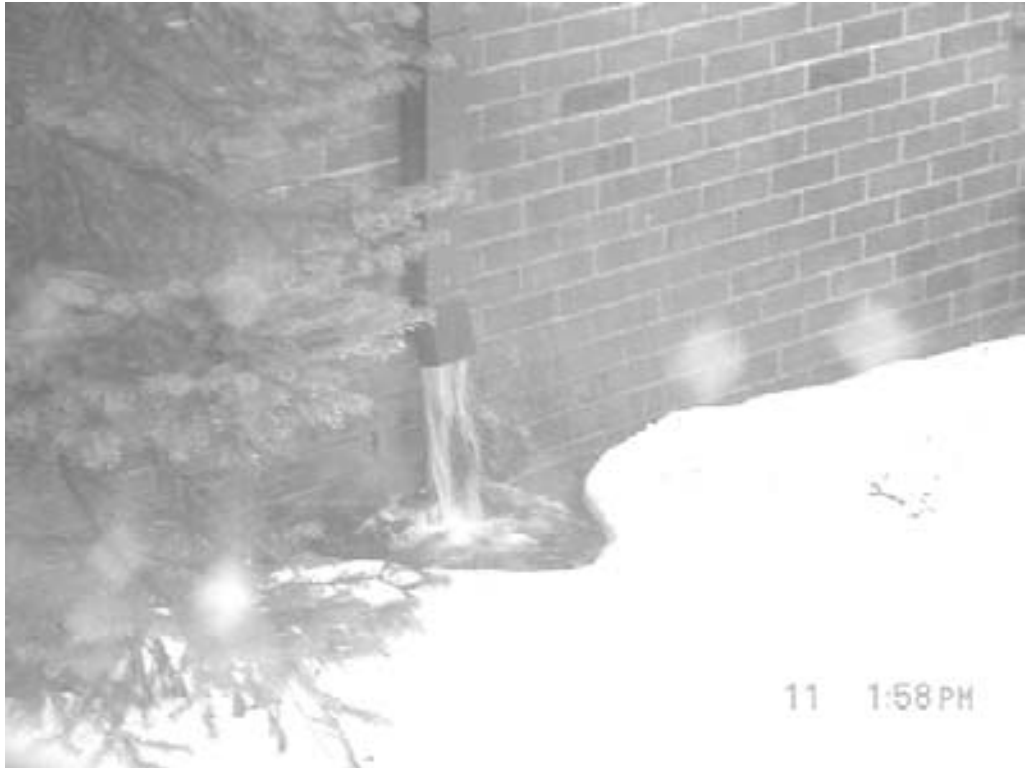
**Picture 4**

The building is equipped with gutters and downspouts to drain rainwater away from the building. Several downspouts were missing elbows causing water to empty and pool against the foundation (Picture 4). Excessive exposure to water of exterior brickwork can result in damage over time. During winter weather, the freezing and thawing of moisture in bricks can accelerate the deterioration of brickwork, which can lead to water intrusion into the interior of the building.

**Downspout With Missing Elbow Emptying Water against the Foundation**

8. Install elbow extensions on downspouts to direct rain water away from the building.
9. Replace any water-damaged ceiling tiles, once leaks are repaired. Examine the area above and beneath these areas for microbial growth. Disinfect areas of water leaks with an appropriate antimicrobial. Clean areas of antimicrobial application when dry.

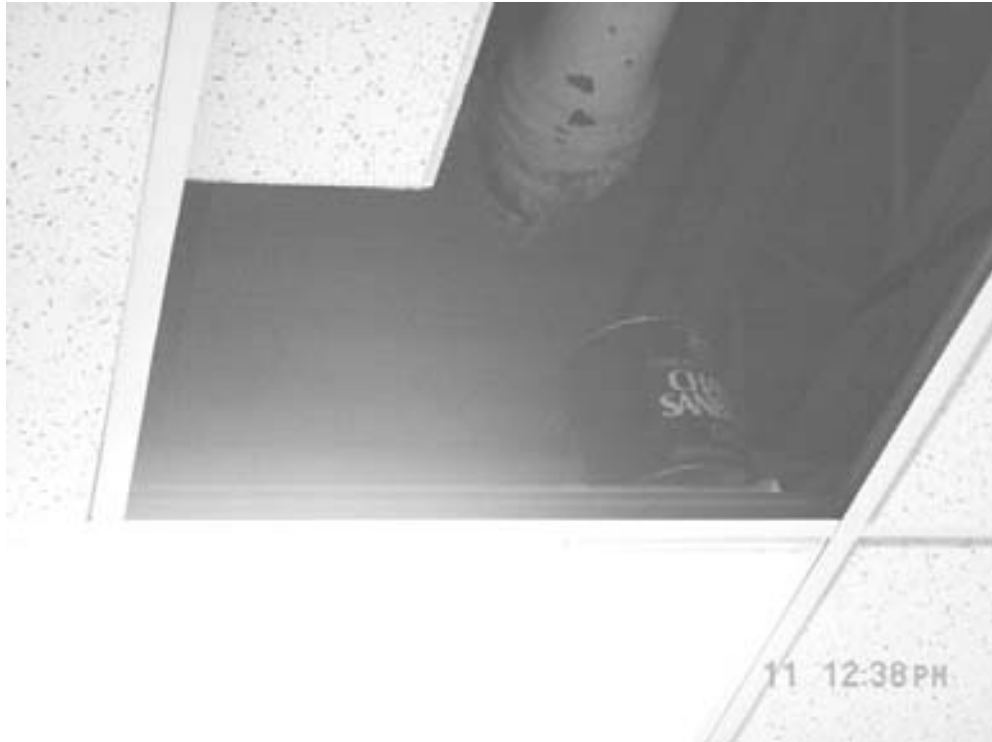
**Picture 5**

A number of areas had water-stained ceiling tiles, which can indicate leaks from the roof or plumbing system. An active leak was observed in the hallway near the kitchen during the assessment. An empty can was placed within the ceiling tile system to catch dripping rainwater that was penetrating through the roof (Picture 5). Water-damaged porous building materials can provide a source for mold and should be replaced after a water leak is discovered and repaired.

**Empty Can Stationed above Ceiling Tile System to Catch Leak**

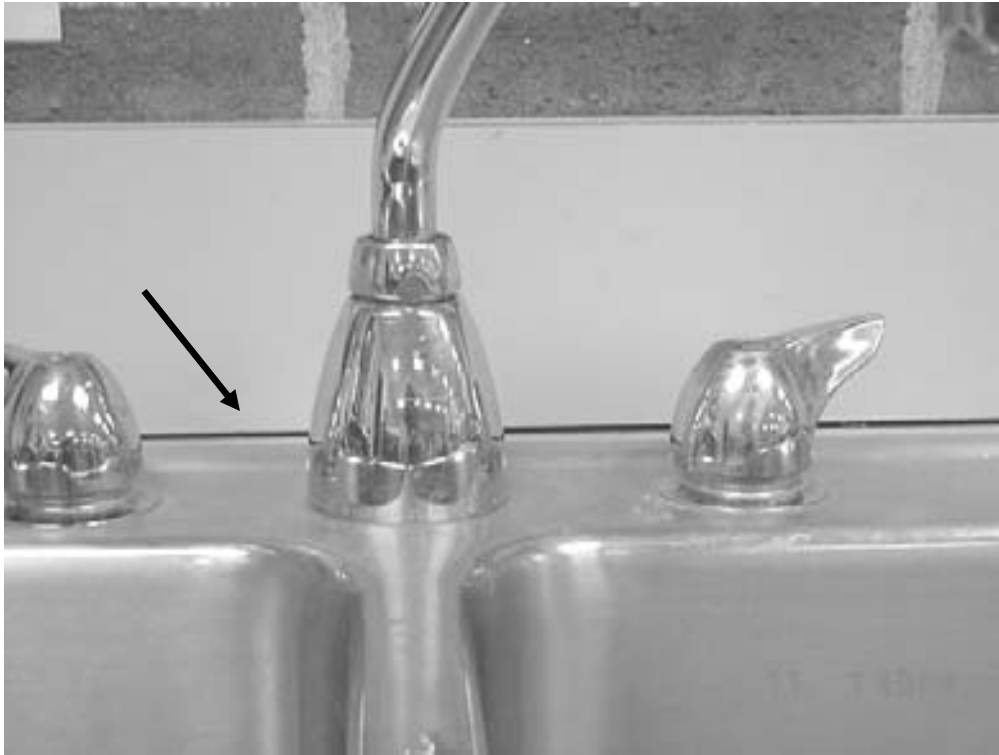
**Picture 6**

Spaces between the sink countertop and backsplash were noted in several areas (Table 1/Picture 6). Improper drainage or sink overflow can lead to water penetration of countertop wood, the cabinet interior and behind cabinets. If porous materials become wet repeatedly they can provide a medium for mold growth.

**Spaces between Sink Countertop and Backsplash**

10. Replace missing or damaged caulking between countertops and sinks. Observe interior of cabinets for water-damage and mold growth. Disinfect with an appropriate antimicrobial where necessary.

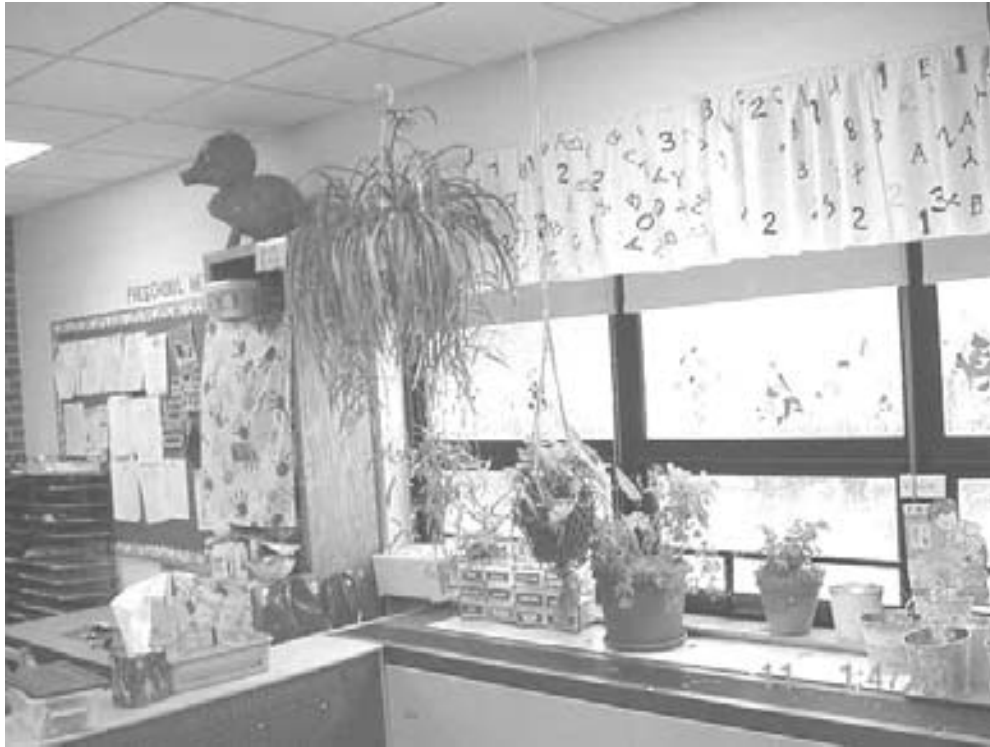
**Picture 7**

Several classrooms had a number of plants. Moistened plant soil and drip pans can be a source of mold growth. Plants are also a source of pollen. Plants should be located away from the air stream of ventilation sources to prevent the aerosolization of mold, pollen or particulate matter throughout the classroom (Picture 7). Plants and shrubbery were also noted outside the building in close proximity to univent air intakes (Picture 8). Plants and shrubbery should be located approximately five feet away from the building to prevent entrainment of pollen and/or moisture.

**Plants on and above Classroom Univent**

12. Remove plants away from univents. Ensure plants have drip pans. Examine drip pans periodically for mold growth and disinfect with an appropriate antimicrobial where necessary.

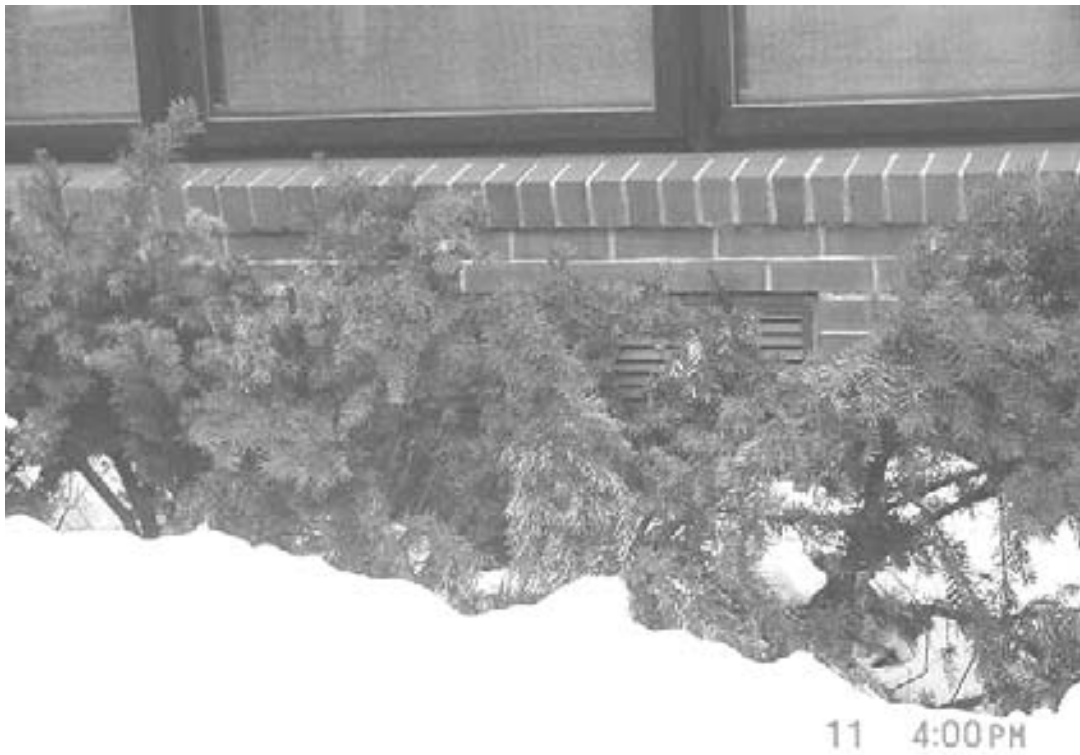
**Picture 8**

**Plants/Shrubbery in Close Proximity to Univent Air Intake**

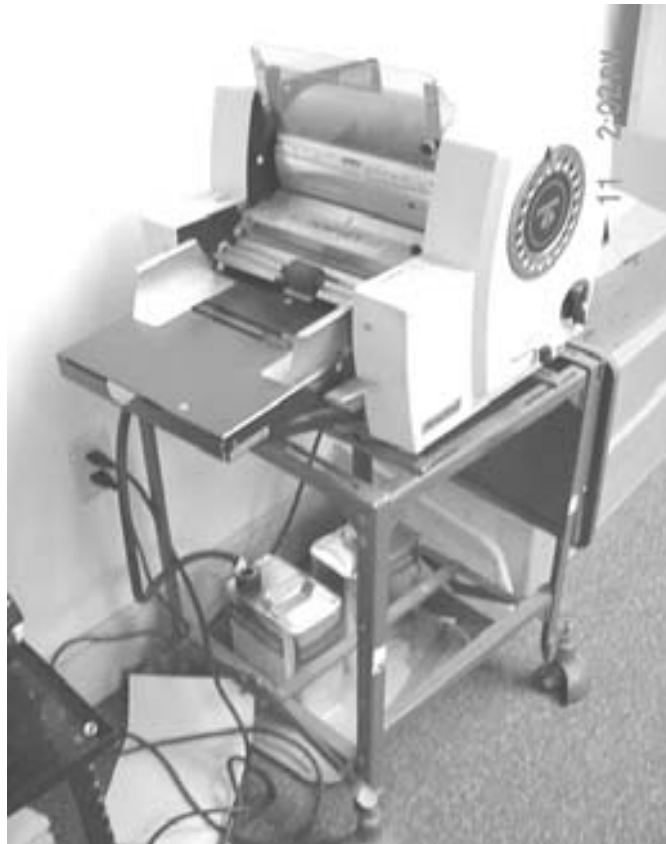
**Picture 9**

In an effort to identify materials that can potentially increase indoor TVOC concentrations, BEHA staff examined classrooms for products containing these respiratory irritants. The media center contained two photocopiers, a lamination machine and a

mimeograph machine with several containers of duplicating fluid (Picture 9). The faculty workroom contains three photocopiers and two lamination machines. Lamination machines can produce irritating odors during use. Mimeograph duplicating fluid contains methanol (methyl alcohol), which is a volatile organic compound that readily evaporates at room temperature. The off gassing of this material can be irritating to the eyes, nose and throat. Methanol is also a highly flammable material, which can be ignited by either flame or electrical source. Lamination machines can produce irritating odors during use. VOCs and ozone can be produced by photocopiers, particularly if the equipment is older and in frequent use. Ozone is a respiratory irritant (Schmidt Etkin, 1992). To help reduce excess heat and odors in these areas, school personnel should ensure that local exhaust ventilation is activated while equipment is in use.

**Mimeograph Machine and Containers of Duplicating Fluid**

14. Ensure local exhaust is operating in the media center workroom to remove excess heat and odors from office machines. Consider discontinuing use of the mimeograph machine.

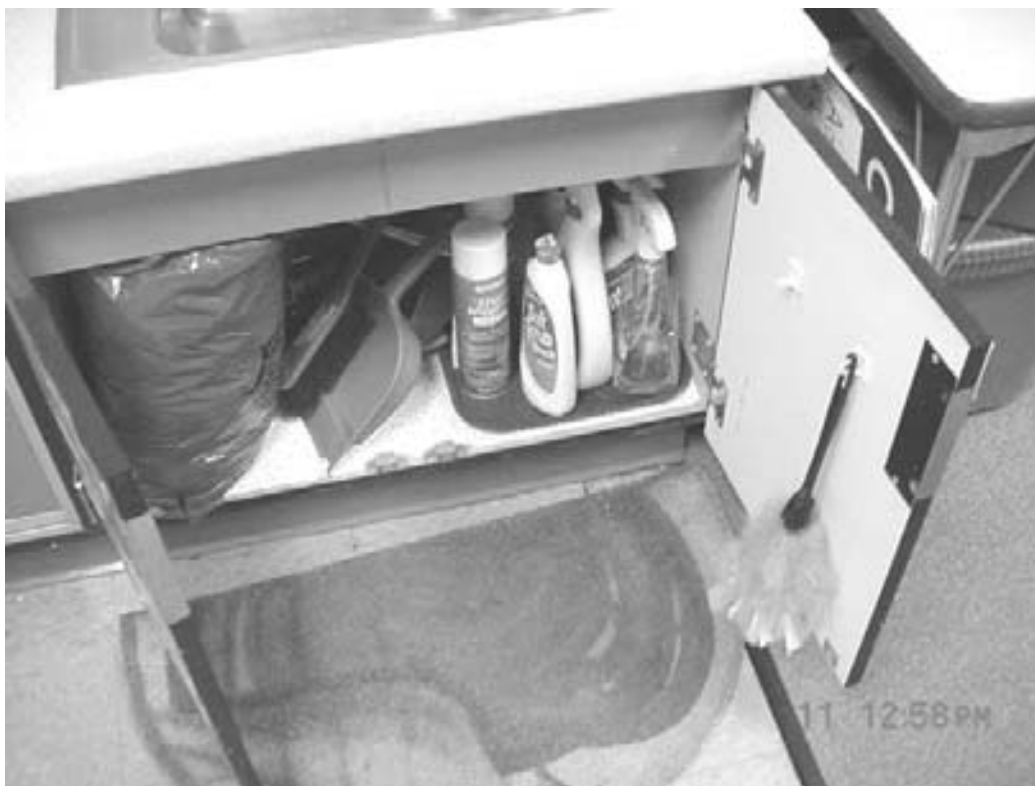
**Picture 10**

Spray-cleaning products were found on countertops and in unlocked storage cabinets beneath sinks in classrooms (Picture 10). Cleaning products contain chemicals that can be irritating to the eyes, nose and throat. Cleaning products should be stored properly and kept out of reach of students.

**Cleaning Products Under Classroom Sink**

16. Consider discontinuing the use of tennis balls on chairs to prevent latex dust generation.
17. Store cleaning products and chemicals properly and keep out of reach of students.

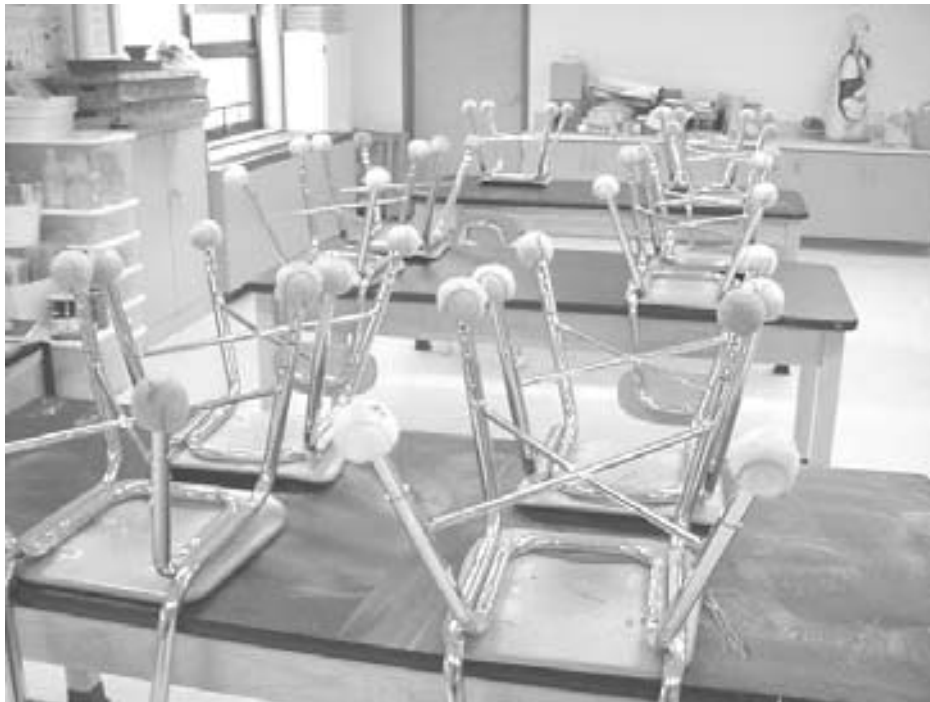
**Picture 11**

In an effort to reduce noise from sliding chairs, tennis balls had been sliced open and placed on chair legs (Picture 11). Tennis balls are made of a number of materials that are a source of respiratory irritants. Constant wearing of tennis balls can produce fibers and lead to off-gassing of VOCs. Tennis balls are made with a natural rubber latex bladder, which becomes abraded when used as a chair leg pad. Use of tennis balls in this manner may introduce latex dust into the school environment. Some individuals are highly allergic to latex (e.g., spina bifida patients) (SBAA, 2001). It is recommended that the use of materials containing latex be limited in buildings to reduce the likelihood of symptoms in sensitive individuals (NIOSH, 1997). A question and answer sheet concerning latex allergy is attached as [Appendix B](#) (NIOSH, 1998).

**Tennis Balls on Chair Legs**

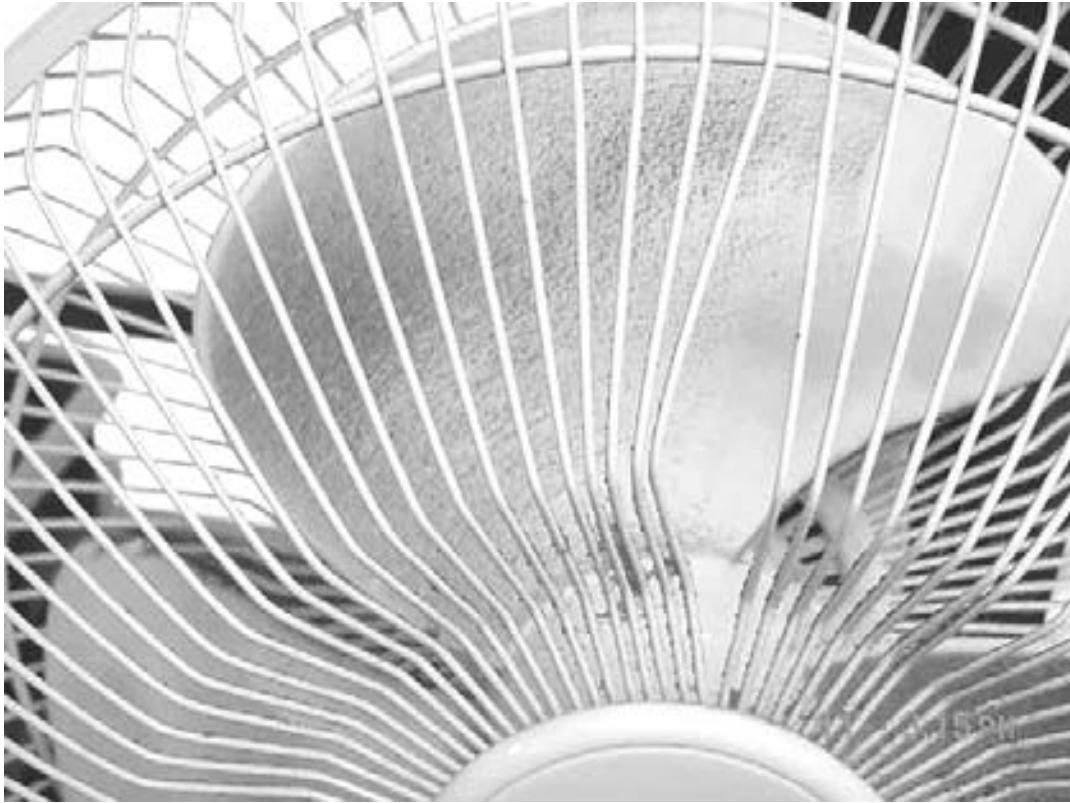
**Picture 12**

Also of note was the amount of materials stored inside classrooms. In classrooms throughout the school, items were observed on windowsills, tabletops, counters, bookcases and desks. The large number of items stored in classrooms provide a source for dusts to accumulate. These items, (e.g., papers, folders, boxes) make it difficult for custodial staff to clean. Dust can be irritating to eyes, nose and respiratory tract. Items should be relocated and/or be cleaned periodically to avoid excessive dust build up. Accumulated dust was also observed on classroom exhaust vents and personal fans (Picture 12). Exhaust vents and personal fans should be cleaned periodically to avoid aerosolizing accumulated dust.

**Accumulated Dust on Personal Fan in Classroom**

18. Clean personal fans and exhaust vents periodically to prevent excessive dust build-up.
19. Refrain from using strongly scented materials (e.g., air fresheners) in classrooms.

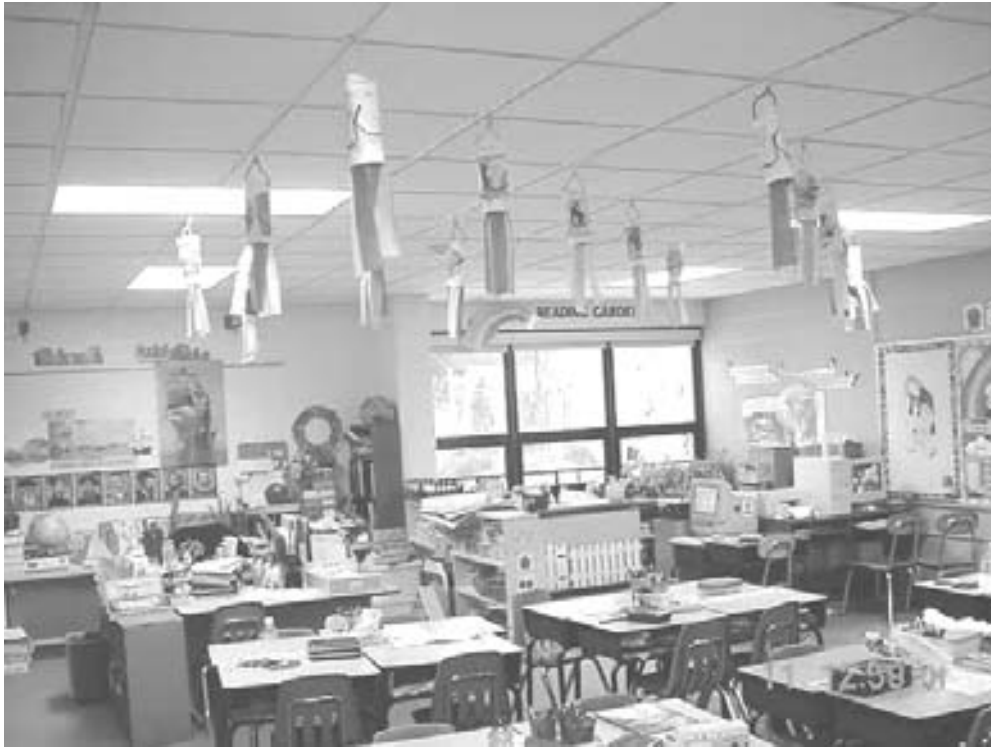
**Picture 13**

Several rooms had various objects hung from the ceiling tile system (Picture 13). The movement of ceiling tiles can provide a pathway for drafts, dusts and particulate matter between rooms and floors. Building occupants should refrain from hanging objects to prevent unnecessary strain to ceiling tile system.

**Items Hanging From Ceiling Tile System**

11. Replace any missing/damaged ceiling tiles, to prevent the egress of dirt, dust and particulate matter into classrooms. Refrain from hanging objects from ceiling tile system.
